C-14-08

BINGOL LISESI (BLDG B)

STRUCTURE (Description)

Dual system

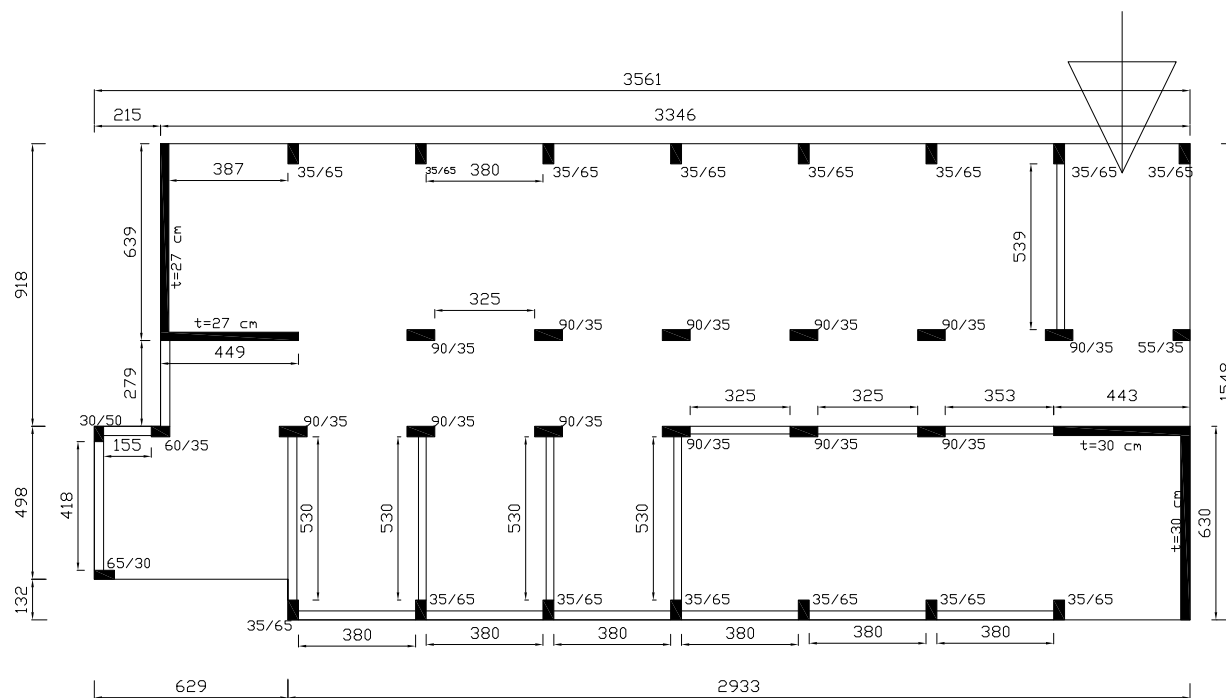
PLAN VIEW

The buildings are separate, but there is no gap between them.  
There are shear and flexure cracks on beams and joints.

All units are in cm.

Masonry wall thickness 30 cm for exterior walls

25 cm for interior walls
